Site Name: Covitch Property / Former ATF Davidson Co.

Location: Northbridge, MA

CERCLIS No.: MAD046128559

TDD No.: 95-07-0065

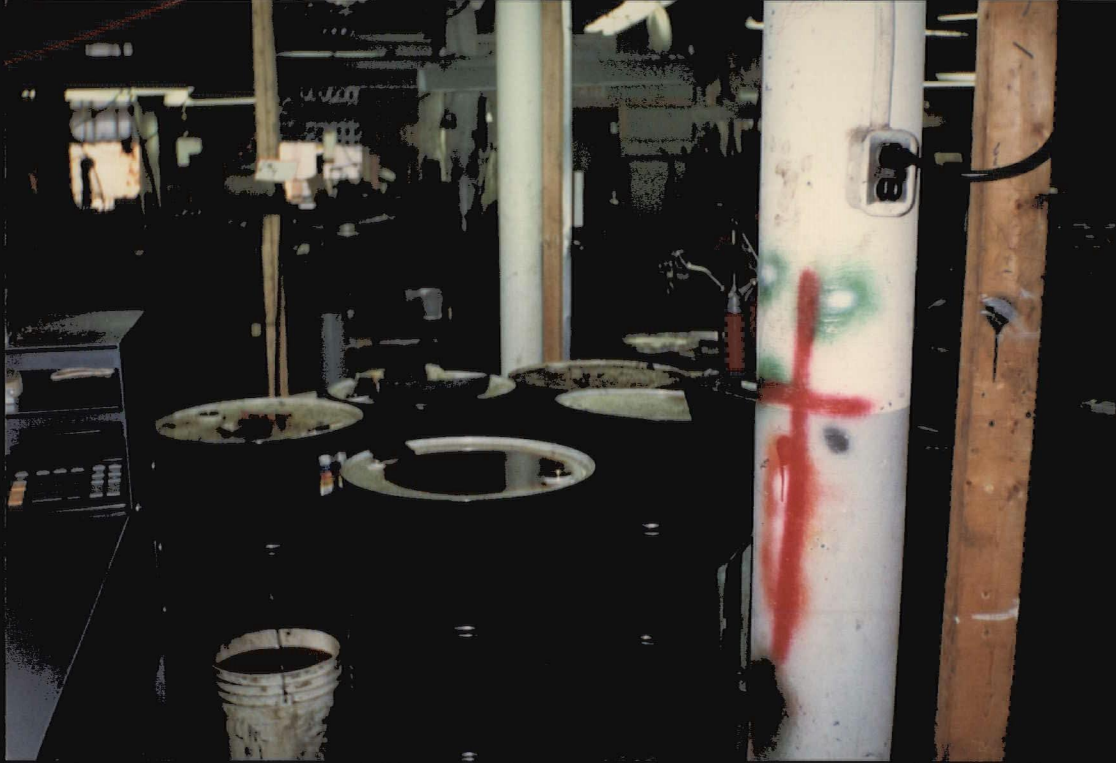
Photo: 4-1

Description: LD = East; six 55-gallon metal drums located at Swissturn, 1st floor, Building No. 4 (cutting oils with additional unknown contents).

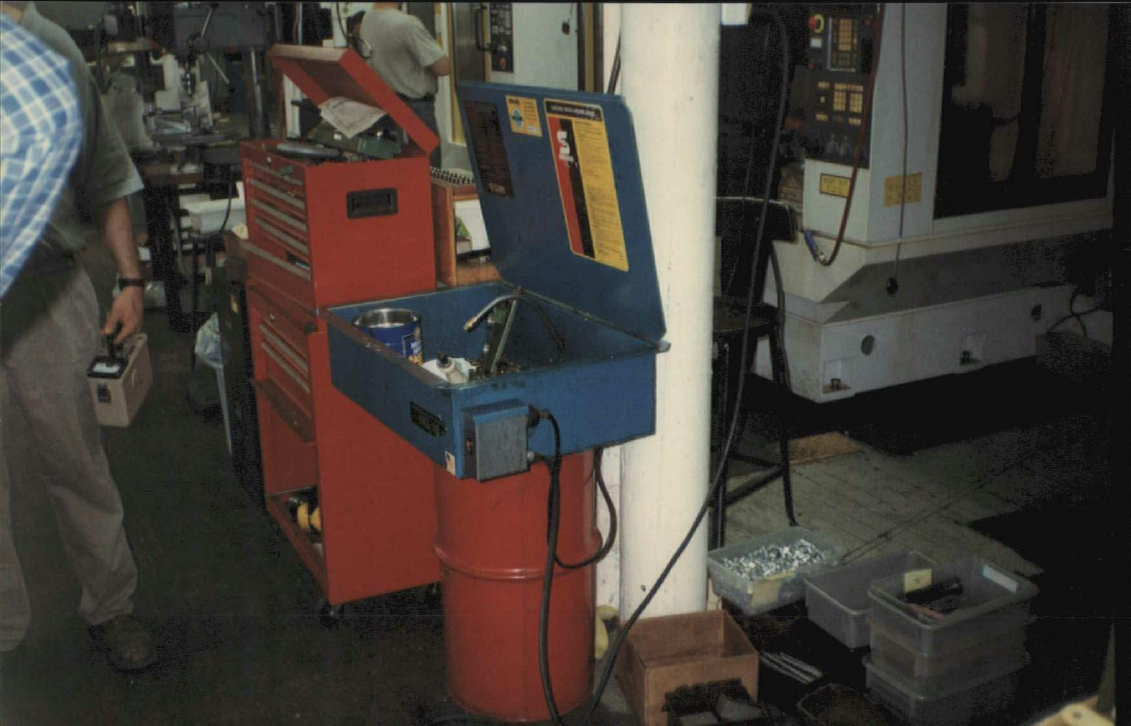
Photo: 4-2

Description: LD = East; solvent parts wash sink at Swissturn,
located in Building No. 4.

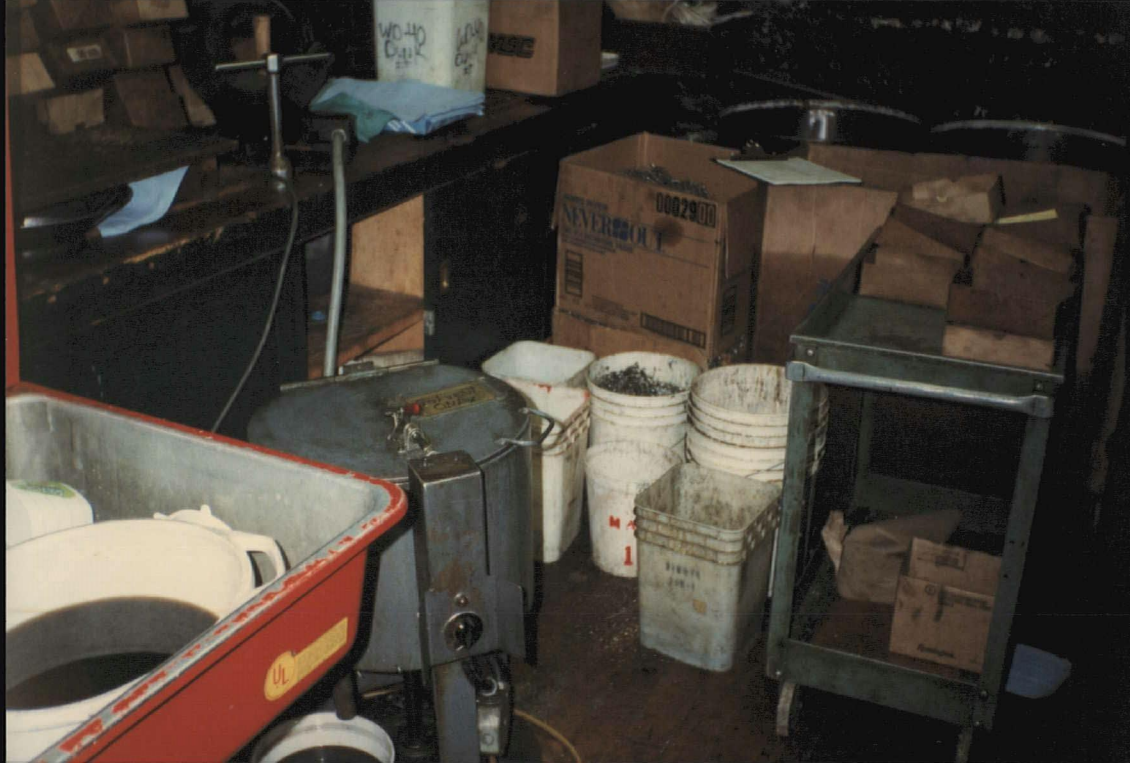
Photo: 4-3

Description: LD = North; various containers of material, including cutting oil mixtures, and metal turnings, located in Building No. 4, at Swissturn. Note: Oil stained flooring.

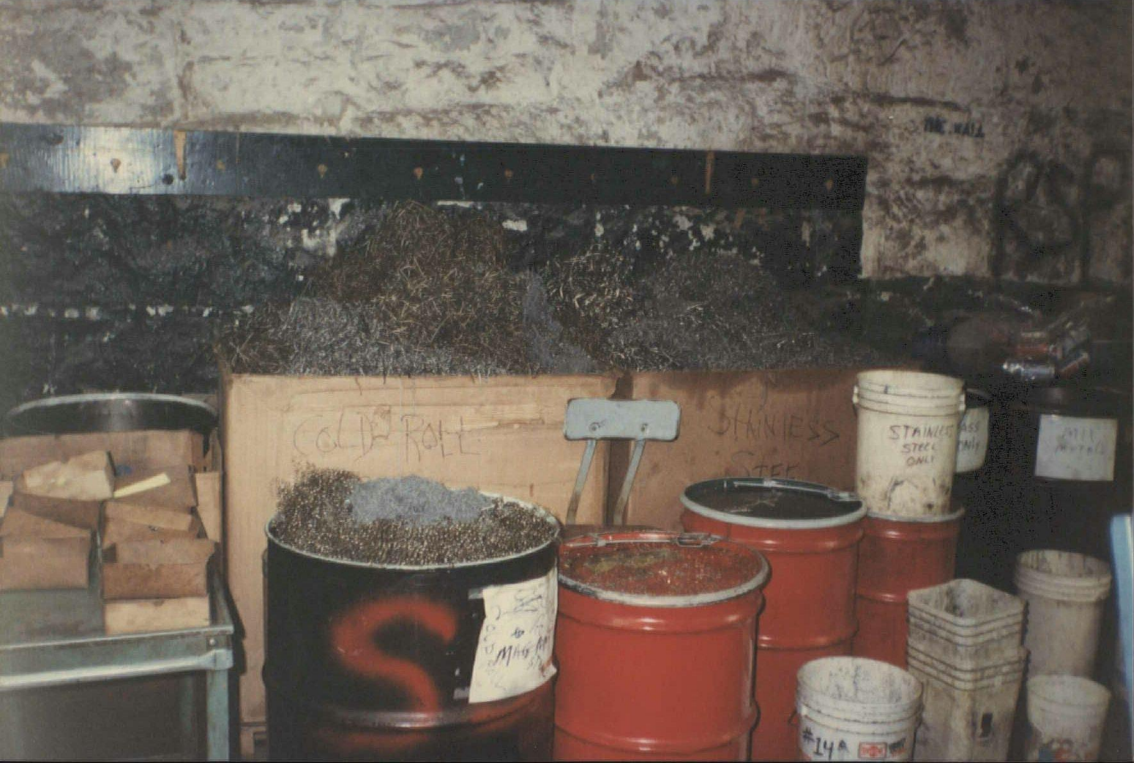
Photo: 4-4

Description: LD = East; various containers of different type metal turnings located in Building No. 4, at Swissturn.

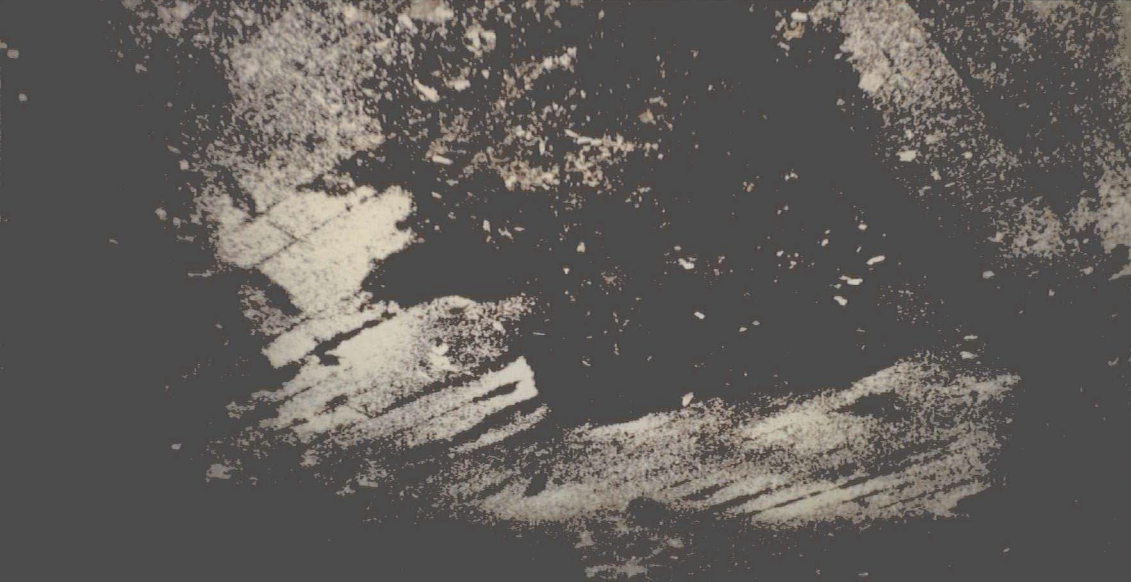
Photo: 4-5

Description: LD = East; oil soaked with absorbent material located in basement of Building No. 4, beneath Swissturn.

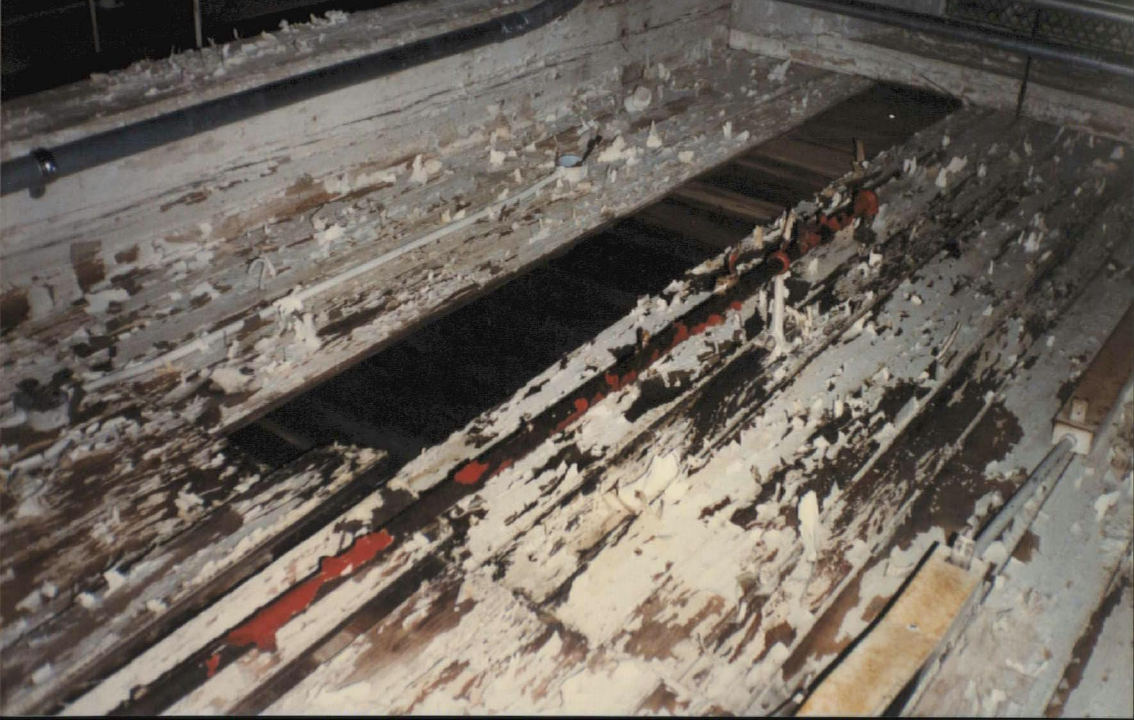
Photo: 4-6

Description: LD = East; oily material leaking through ceiling boards Building No. 4, beneath Swissturn (basement).

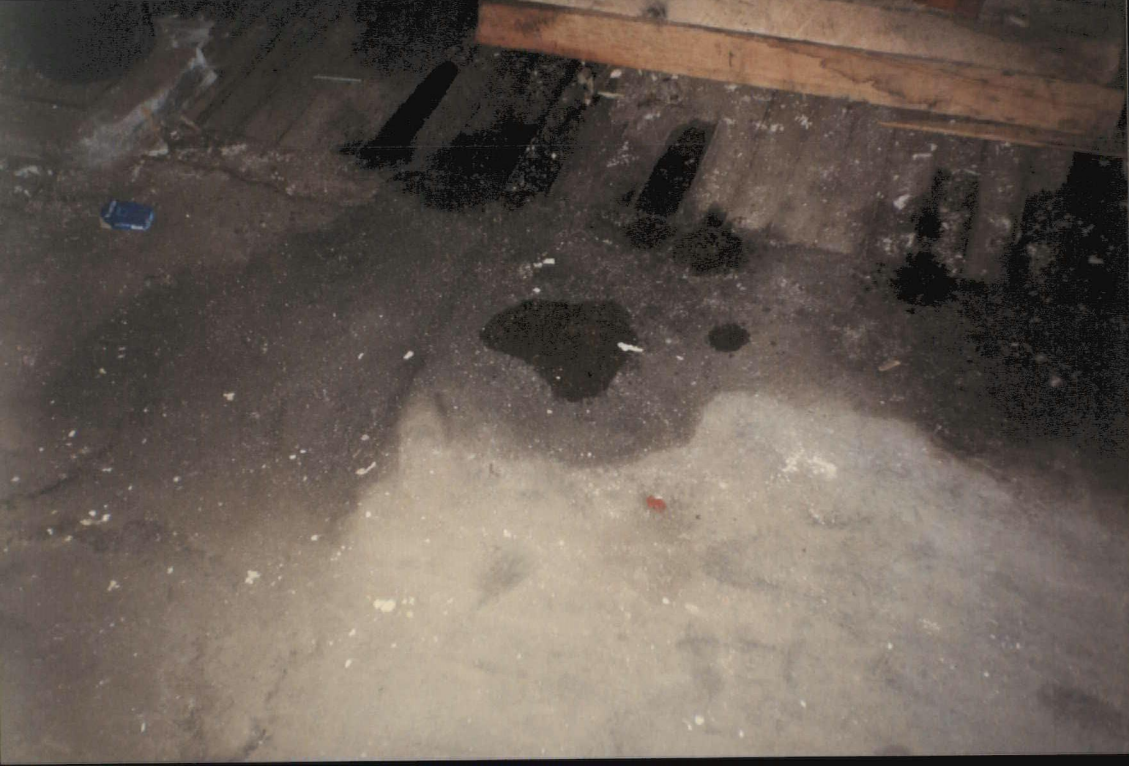
Photo: 4-7

Description: LD = East; oil puddle on floor of basement below
Swissturn, Building No. 4. (Directly below photograph No. 4-6).

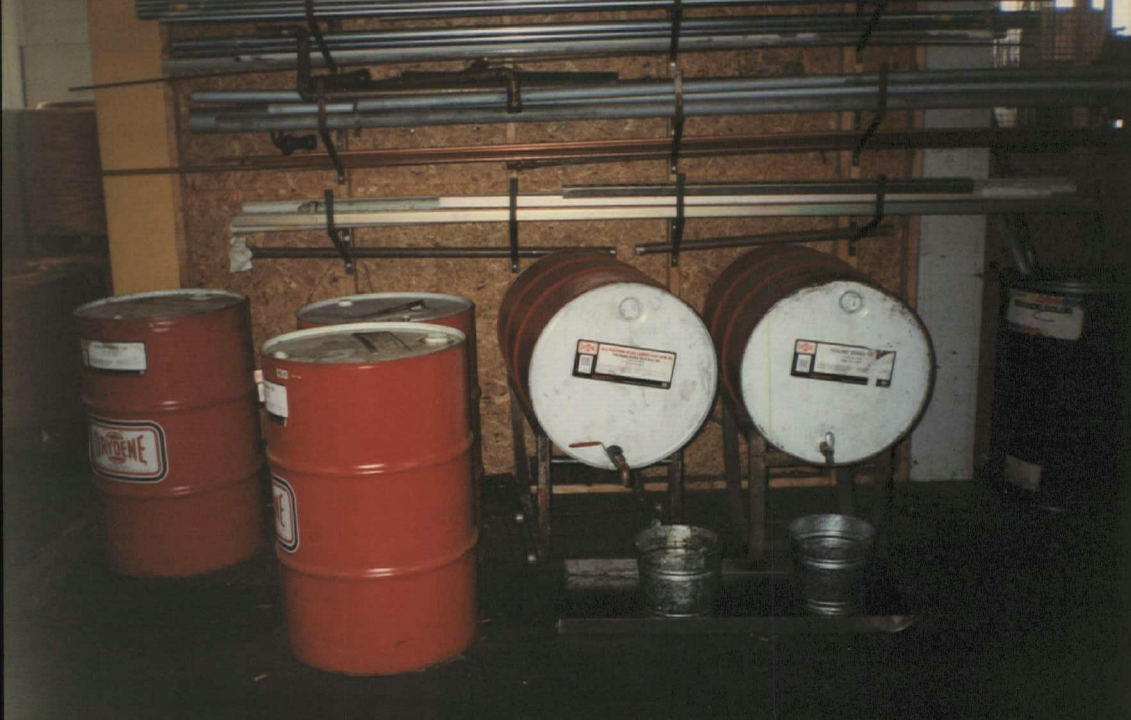
Photo: 4-10

Description: LD = East; five metal 55-gallon drums of gear lubricant at Commtran, second floor, Building No. 4. Note: Catch pan.

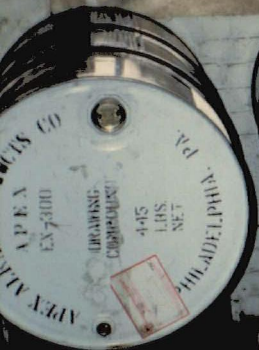
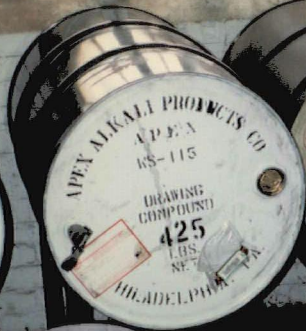
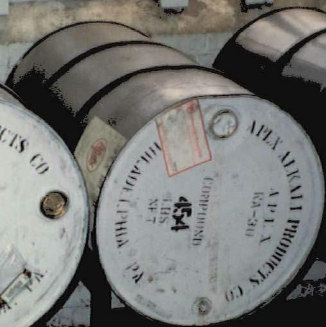
Photo: 4-11

Description: LD = South; five metal 55-gallon drums of drawing compound located at Commtran, second floor, in Building No. 4.

Note: Stained flooring and absorbent material.

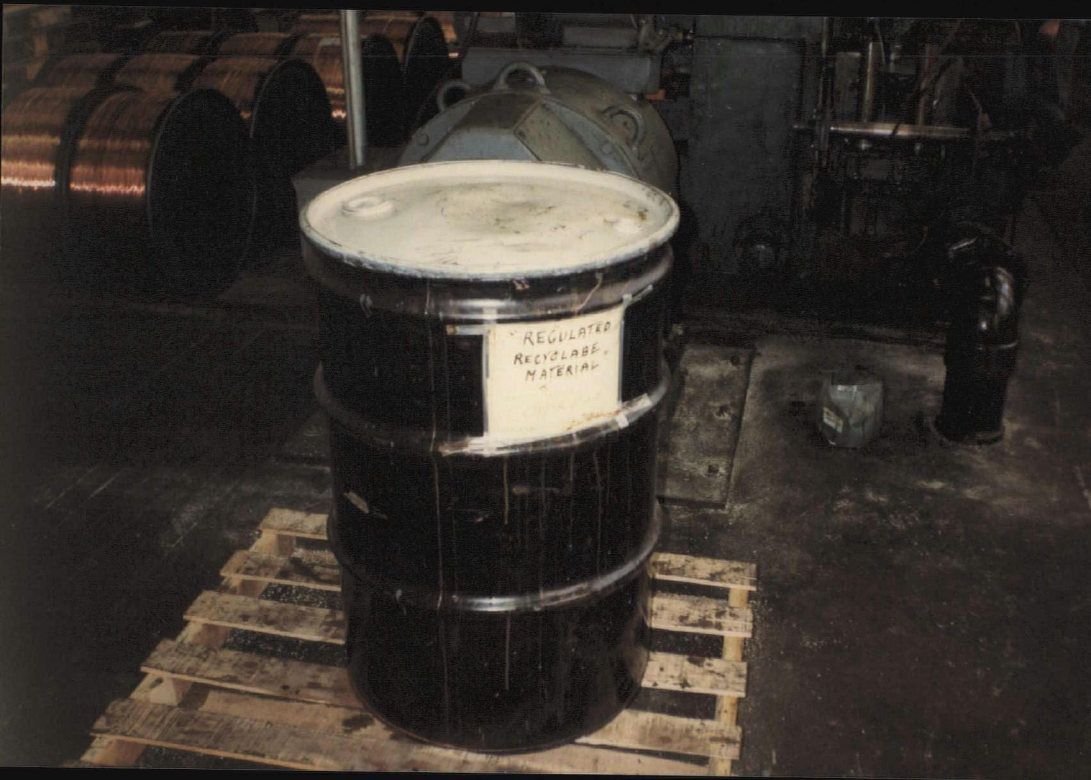
Photo: 4-12

Description: LD = West; one metal 55-gallon drum labeled "regulated recyclable material," (contents unknown); also note stained concrete flooring and plastic jug to catch oil drips; Commtran, 2nd floor, Building No. 9.

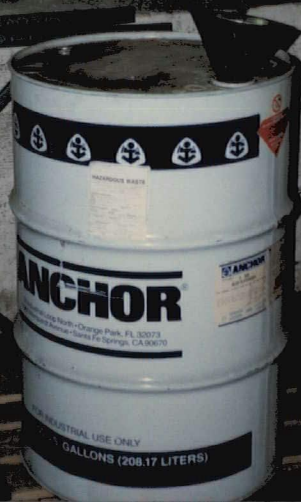
Photo: 4-13

Description: LD = North; one metal 55-gallon drum labeled hazardous waste (plasticizer), located at Alan Bailey Tag & Label Co. in Building No. 11.

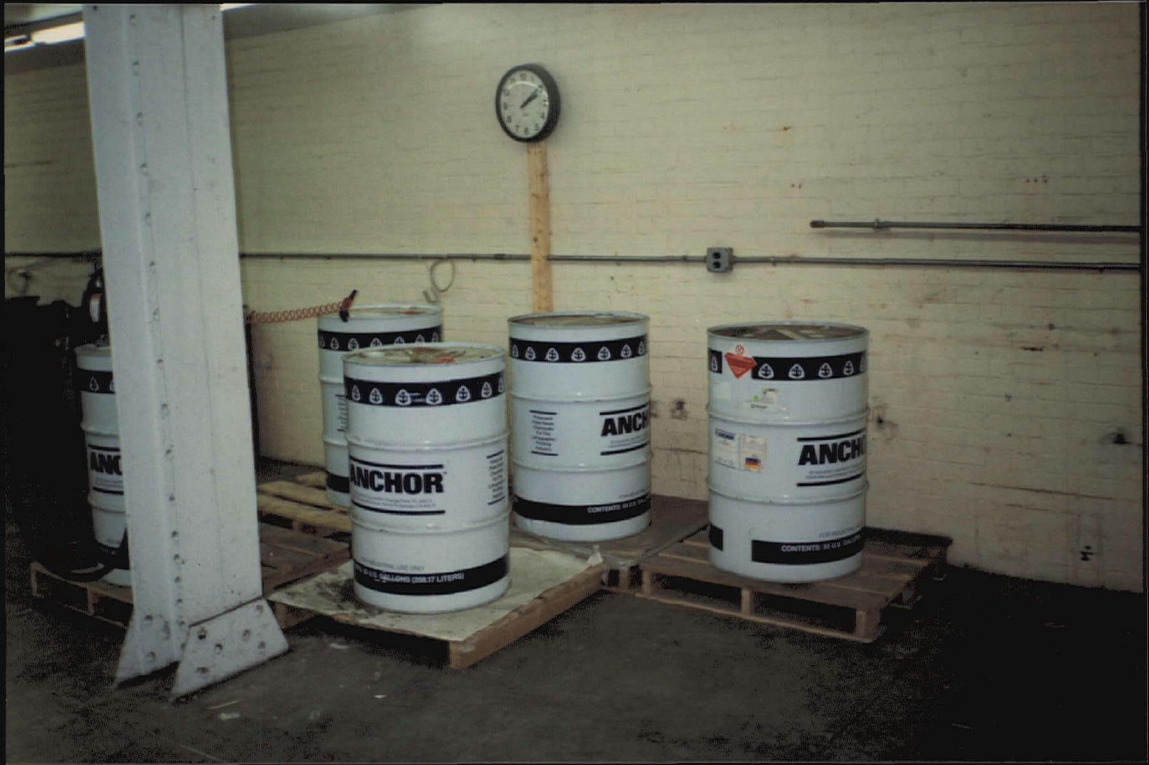
Photo: 4-14

Description: LD = West; five metal 55-gallon drums of hazardous material (plasticizer) located at Alan Bailey Tag & Label Co. in Building No. 11. No floor staining observed.

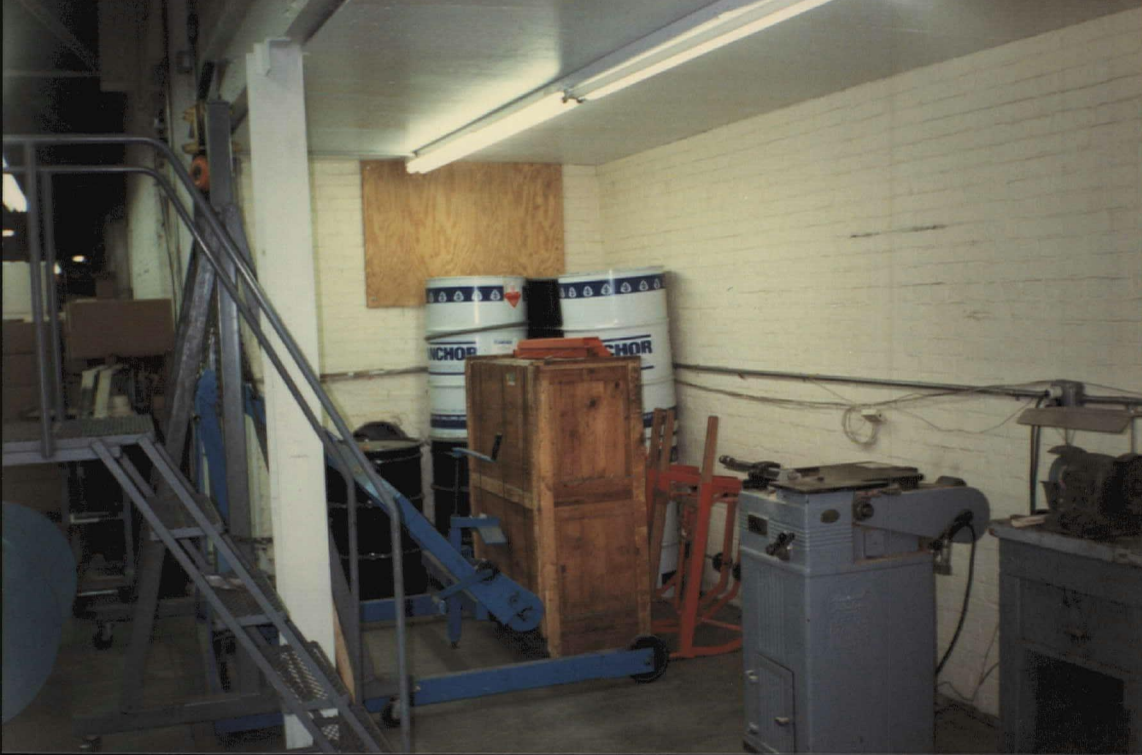
Photo: 4-15

Description: LD = Southwest; seven metal 55-gallon drums (2 plasticizers, 5 of unknown contents) located at Alan Bailey Tag & Label Co. in Building No. 11.

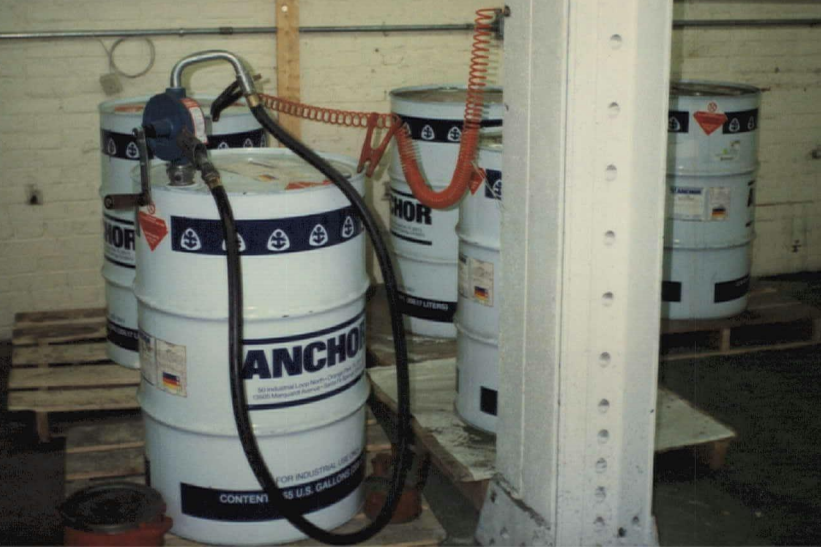
Photo: 4-16

Description: LD = Northeast; five metal 55-gallon drums located at Alan Bailey Tag & Label Co. in Building No. 11 (same subject as photos No. 4-14 with different LD).

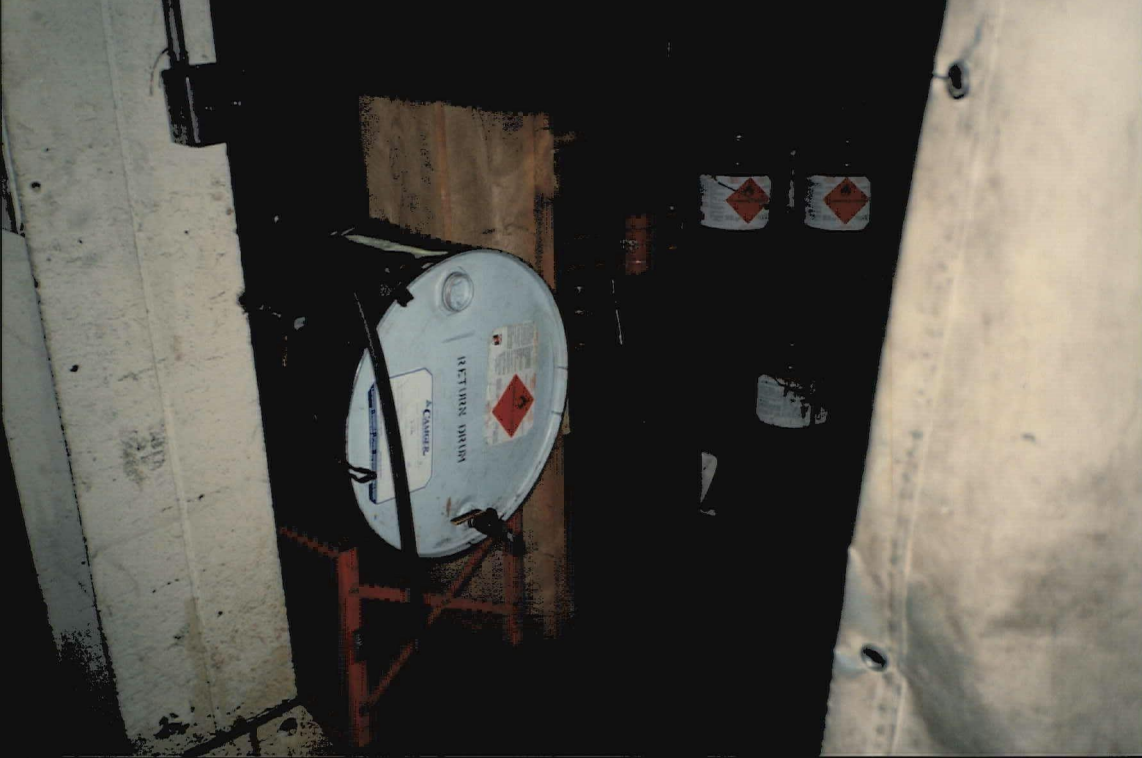
Photo: 4-17

Description: LD = North; various containers of naphtha solvents located as Tomkins Corp., first floor, Building No. 12. Note:
Peeling labels and stained concrete flooring.

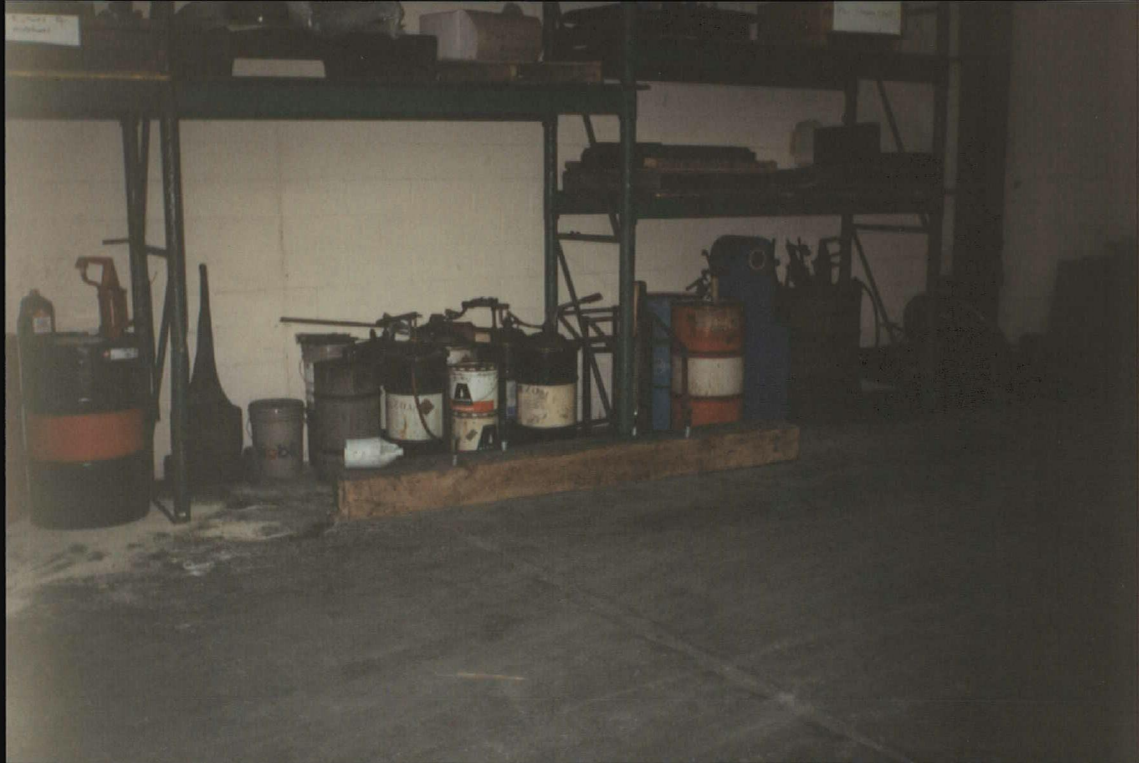
Photo: 4-18

Description: LD = West; various containers of oil material, note stained concrete flooring and absorbent material present. Materials located at Tomkin Corporation, 1st floor, Building No. 12.
[Composite 1 of 3 (4-13 through 4-20)]

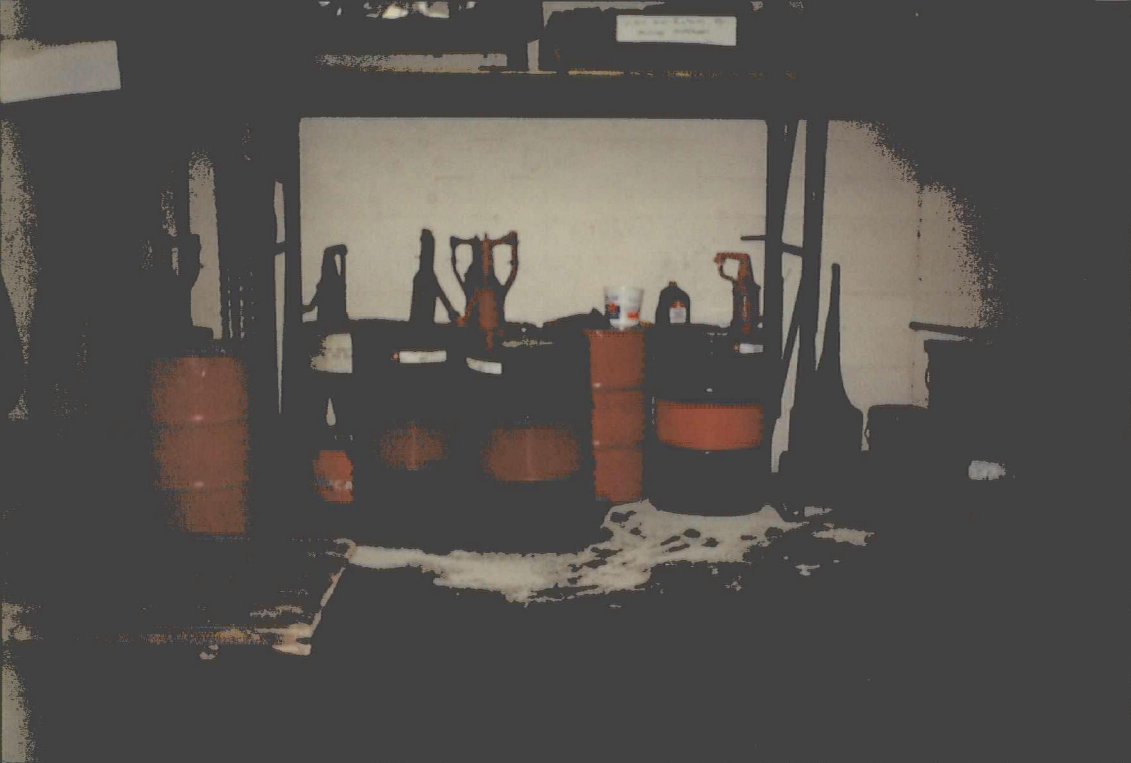
Photo: 4-19

Description: LD = West; various containers of oil material, note stained concrete flooring and absorbent material present. Materials located at Tomkin Corporation, 1st floor, Building No. 12.
[Composite 2 of 3 (4-13 through 4-20)]

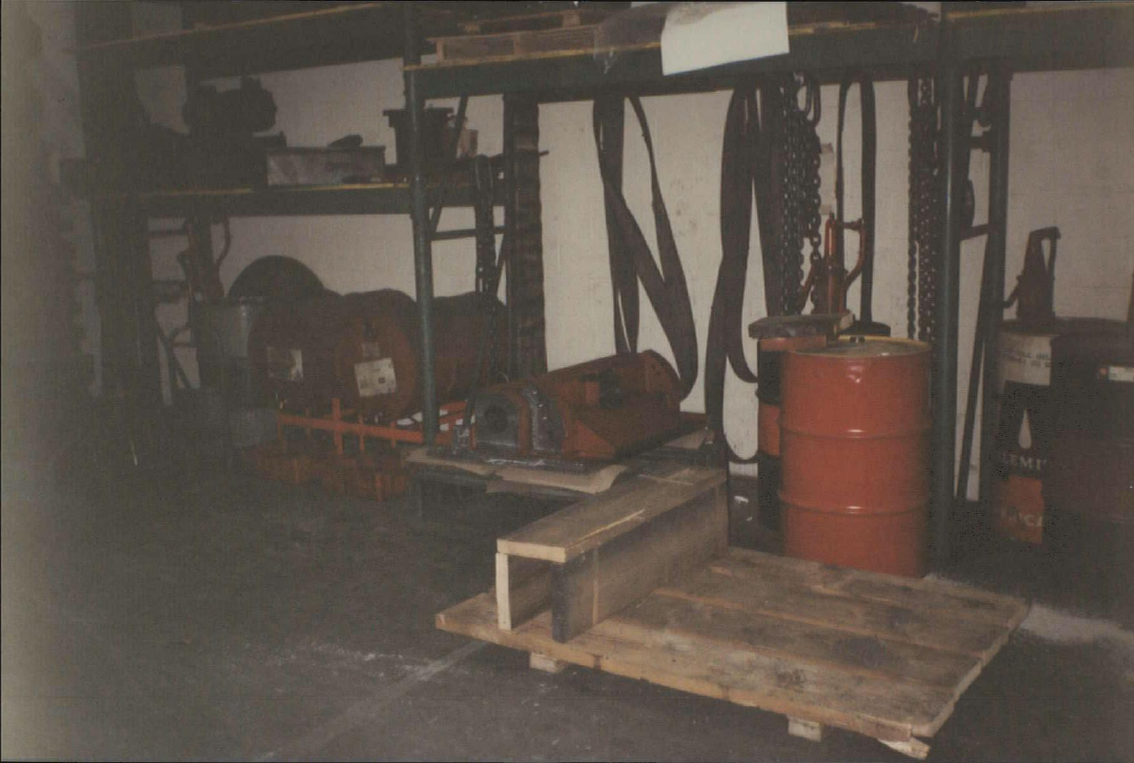
Photo: 4-20

Description: LD = West; various containers of oil material, note stained concrete flooring and absorbent material present. Materials located at Tomkin Corporation, 1st floor, Building No. 12.

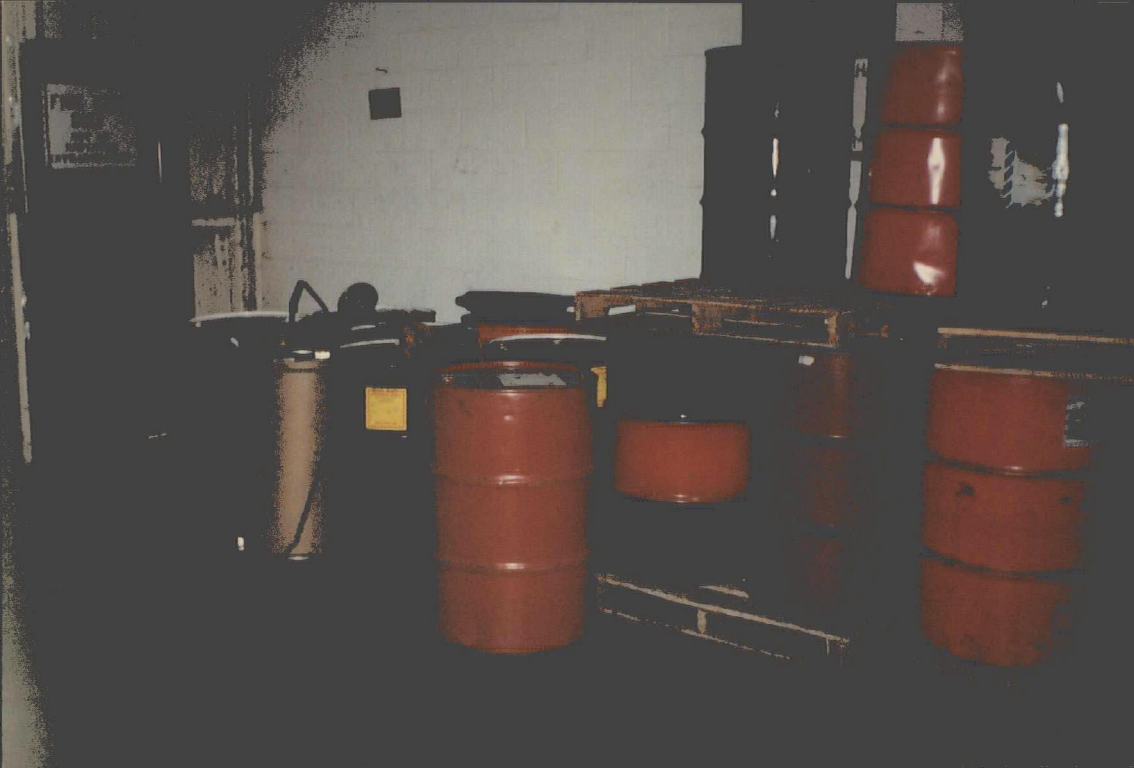
Photo: 4-22

Description: LD = West; 28 metal 55-gallon drums of "waste oils" and 1 fiberboard drum of unknown material at Tomkins Corp., 1st floor, in Building No. 12. [Composite 2 of 2 (4-21 through 4-22)]

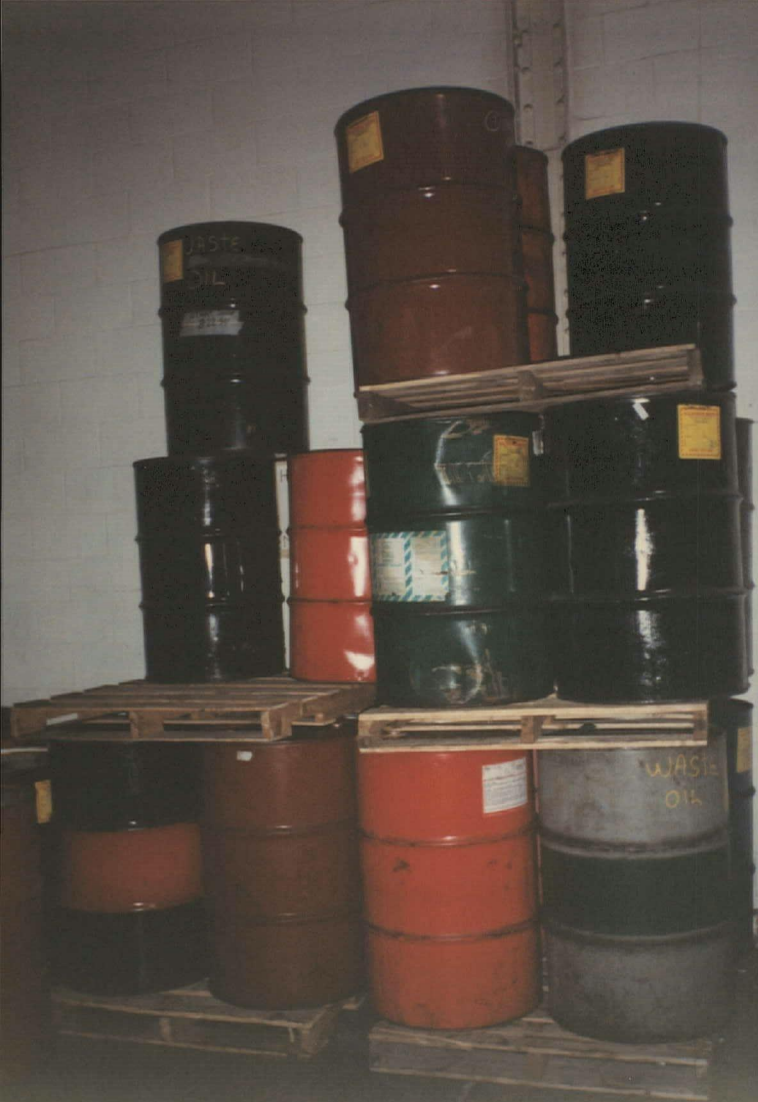
Photo: 4-21

Description: LD = West; 28 metal 55-gallon drums of "waste oils" and 1 fiberboard drum of unknown material at Tomkins Corp., 1st floor, in Building No. 12. [Composite 1 of 2 (4-21 through 4-22)]

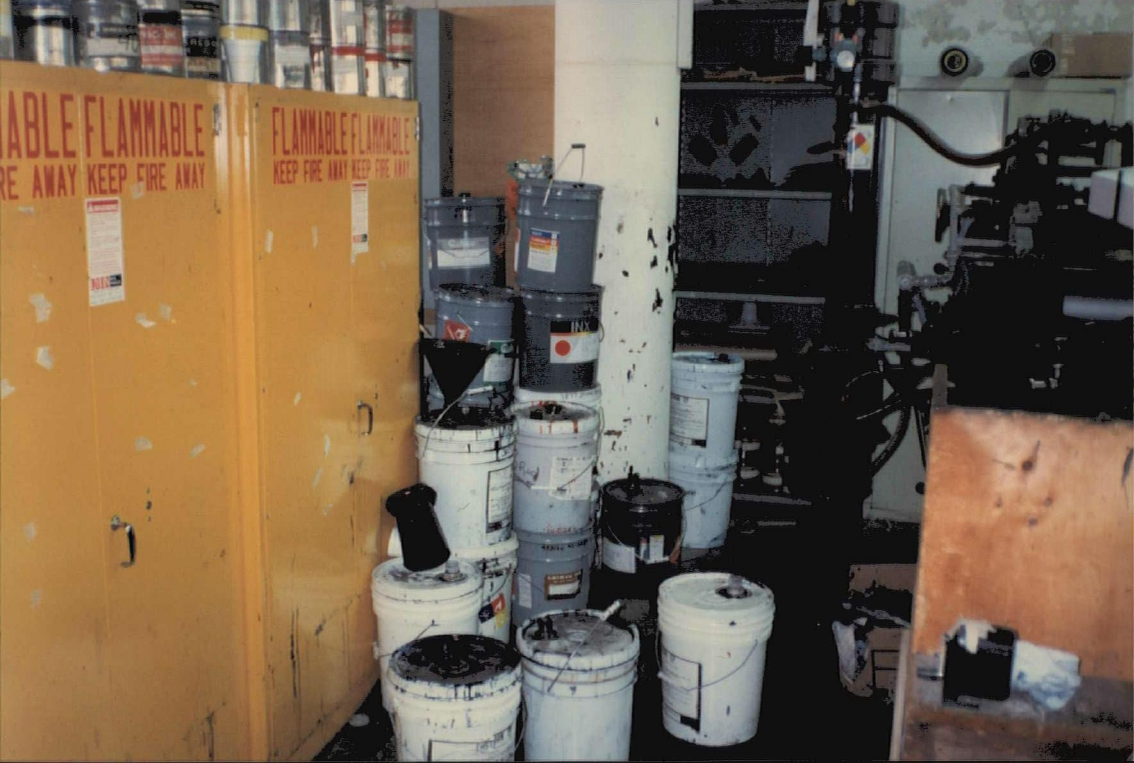
Photo: 4-23

Description: LD = North; numerous containers of printing ink and flammable material located at Classic Envelope, second floor, Building No. 10. Note: Staining and storage techniques.
